Australian Government  
Civil Aviation Safety Authority

**SERVICE DIFFICULTY REPORTS**

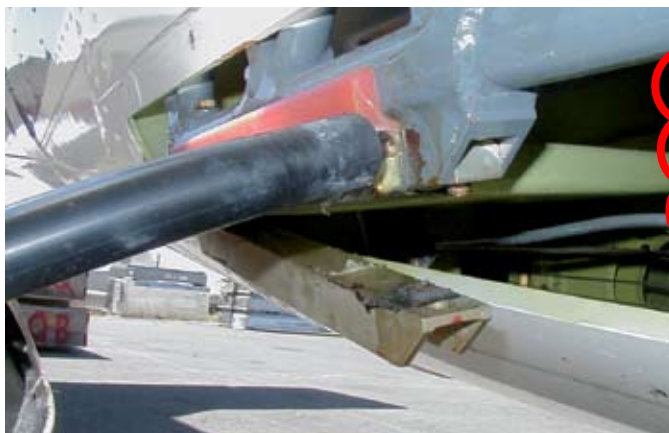
**Partenavia P68C Main landing gear attachment bolt broken. Ref 510004254 (photo below)**

RH main landing gear side support trestle gear spring retainer channel forward bolt broken. Bolt was still in trestle with the broken threaded section and nut found in the fairing. Found when fairing removed during troubleshooting for hydraulic leak. P/No: AN527A. TSN: 737 hours.
